Test Type: Consultation/Investigation

SAMPLE IDENTIFICATION:

Three (3) samples, hardcoat anodized aluminum. Two samples were coupons identified as K100 and C250 (5000 series cast alloy). The third sample was an actual part made of MIC-6 (7000 series) cast alloy.

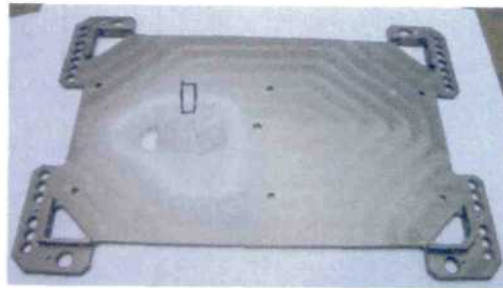
The MIC-6 alloy part is one of about a 25% reject rate obtained from similar parts after hardcoat anodizing. These rejects evidence a severe burning/chemical attack to the point where the aluminum is perforated (see photo above). The two coupons made for an alternate alloy were submitted for comparison purposes, as parts made from these alloys undergo the same anodizing process and do not evidence the problem.

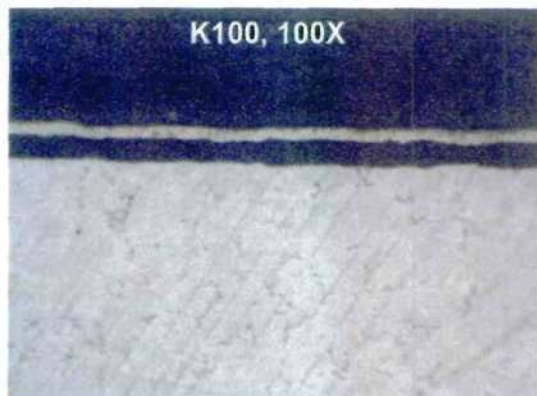
The MIC-6 part had a very porous structure with large portions of the aluminum evidencing dendritic silicon inclusions. The 500 series coupons had far less porosity and no large dendritic silicon inclusions as shown in the photos below. Since silicon does not conduct electricity, large amounts of secondary phase silicon can produce localized resistance heating. This combined with the high level of porosity results in aggressive localized attack of the aluminum during the anodizing process.

K100 and C250 Cross sections at 100X. Note significantly different structure.

The K-100 or C250 alloy coupons have a more sound microscopic structure that lends itself to hardcoat anodizing, while the part made of MIC-6 will result in a high level of reject rates due to the high level of porosity and presence of large localized silicon dendrites. This is a material problem that can not be resolved by changing the anodizing process.
